Technical Report 867

STUDY OF FISH BITE ON THE AN/BQR-15 TOWED ARRAY

November 1982

Report for period: February - November 1982

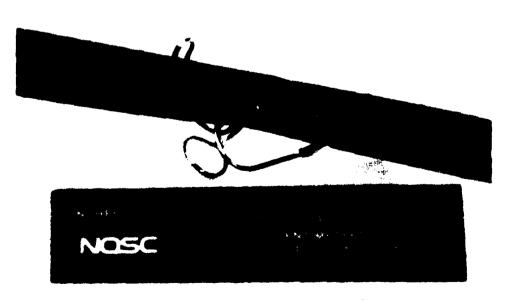
Figure 2a. Shown here are the results of two bites by the lemon shark shown in figure 1

The lemon shark had no difficulty in penetrating the thin array boot. As can be seen in figure 2a, the shark also severed some of the Kevlar strands molded into the boot. This shark was approximately 2.7 m long and weighed about 150 kg. The blue shark was about 2.4 m long and weighed approximately 75 kg. In this case, the shark did not bite completely through the boot, but only penetrated to the Kevlar strength cords (fig. 2b). We were unable to reproduce the long slashes observed on some of the damaged arrays (ref. 3).

In each case, the damage by the sharks' bites was probably less than one would expect under actual conditions of tow because the bites had to go through at least part of the fish fillets in order to reach the boot.

A large lemon shark had no difficulty in penetrating the boot and Kevlar strength cords of the array. A smaller, less powerful blue shark only bit through the array boot, but did not sever the strength cords. We conclude from this that, if bitten by one of several species of large sharks (8 ft long or longer), the thin version of the BQR-15-array can be severely damaged.

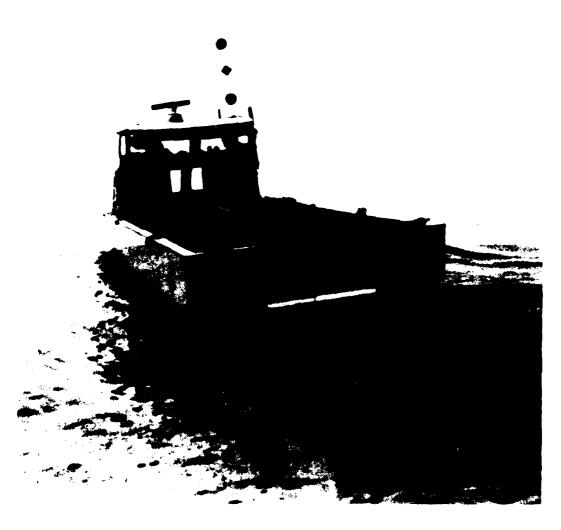
Figure 4a. View of the forward end of the arrays.

Figure 4b. View of the aft end of the arrays. The drogue for the small array was made from a 2.5-m section of 8-cm-diameter hose.
